Case Study – HPU Upgrade

Product Line – Hydraulic Power Unit

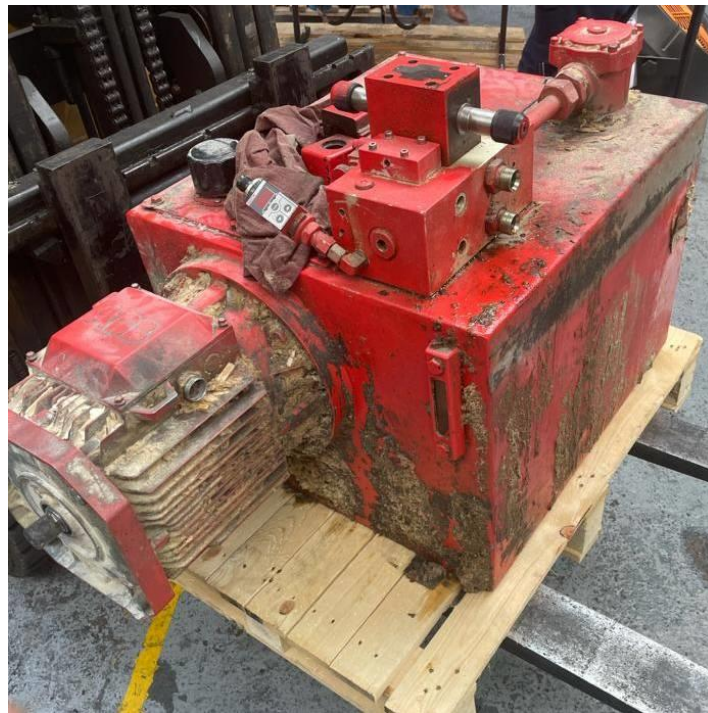
A customer delivered a hydraulic power unit that was losing pressure internally. The fault was found to be a crack in the manifold due to a previous repair to a bolt hole. Further investigation revealed a collapsed return filter, an electric motor with out a fan cover, oil that was black in colour and all components in a general poor condition.

The tank was stripped down, shot blasted and repainted. A new gear pump and electric motor was fitted to the bell housing. A new return filter element and breather were fitted to the tank. The manifold was replaced with a new Cetop 5 block, completed with new directional valve, relief valve and new Hydac pressure transmitter.

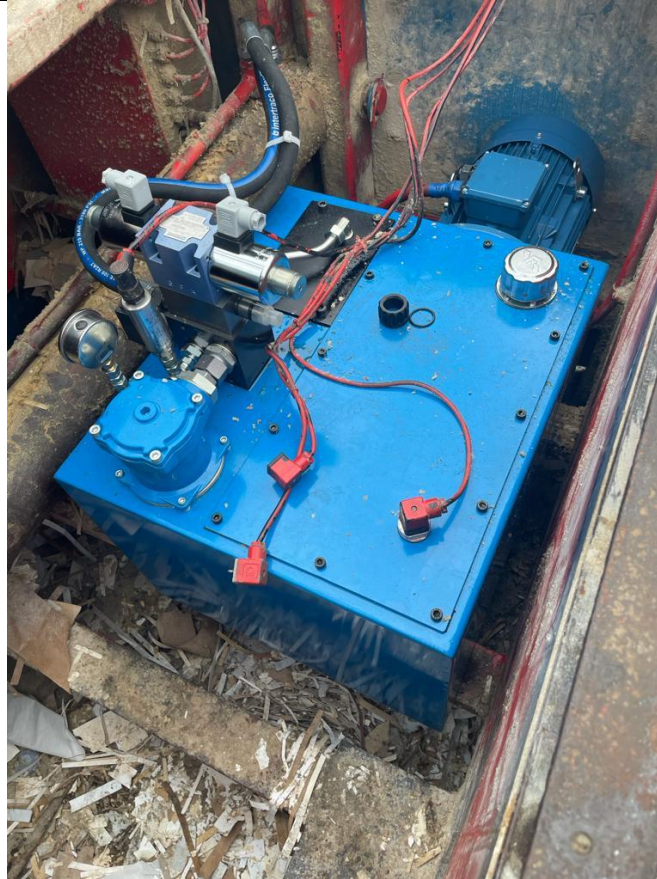
The Power Unit was fully tested before despatch.
